# Influence of surface treatment and cyclic loading on the durability of repaired all-ceramic crowns

**O**bjective: This study investigated the durability of repaired all-ceramic crowns after cyclic loading. Material and methods: Eighty In-ceram zirconia crowns were fabricated to restore prepared maxillary premolars. Resin cement was used for cementation of crowns. Palatal cusps were removed to simulate fracture of veneering porcelain and divided into 4 groups (n = 20). Fracture site was treated before repair as follows: roughening with diamond bur, (DB); air abrasion using 50  $\mu\text{m}$   $\text{Al}_2\text{O}_3$ , (AA) and silica coating using Cojet system followed by silane application, (SC). Control group (CG) 20 specimens were left without fracture. Palatal cusps were repaired using composite resin. Specimens were stored in water bath at 37°C for one week. Ten specimens of each group were subjected to cyclic loading. Fracture load (N) was recorded for each specimen using a universal testing machine. Two-way analysis of variance (ANOVA) and Tukey honestly significant difference (HSD) test ( $\alpha=.05$ ) were used for statistical analysis. Results: There was statistically

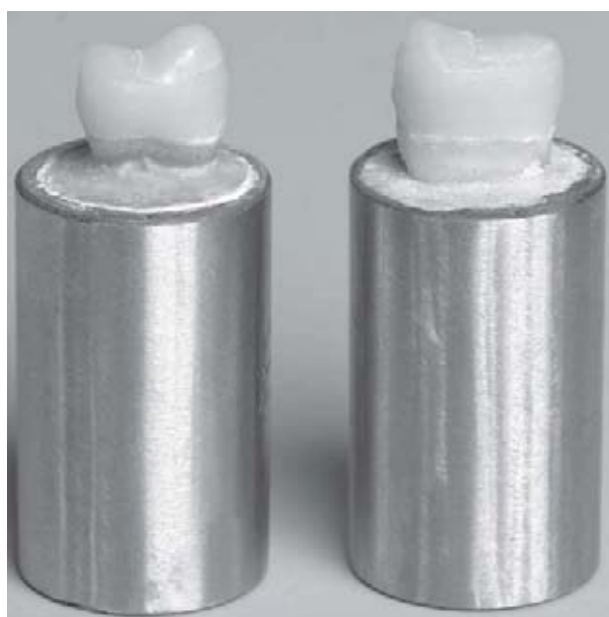
**Figure 1-** Fractured and repaired specimens

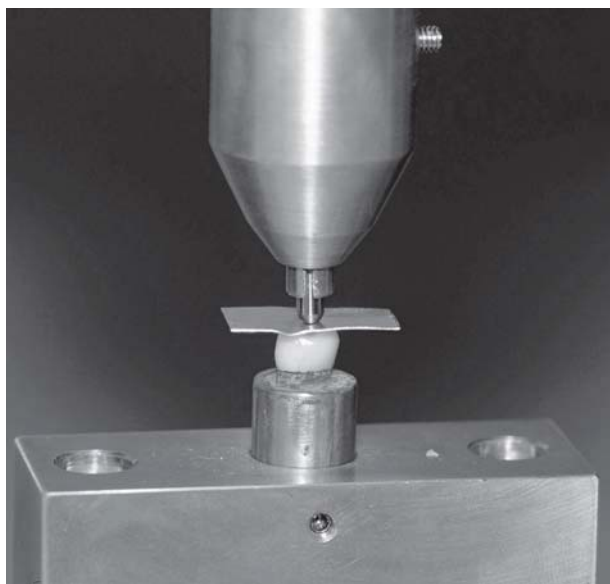
**Figure 2-** Applying the compressive load along the long axis of test and control specimens

repaired cusp, a 1 mm thin piece of polyethylene vacuum-forming foil (copyplast 1.0, Scheu-Dental, Iserlohn, Germany) was placed between the stainless steel bar and the crown (Figure 2). The compressive load required to cause fracture (N) was recorded for each specimen (Figure 3). Two-way analysis of variance (ANOVA) followed by serial one-way ANOVA with and without cyclic and Tukey's HSD test at significance level of .05

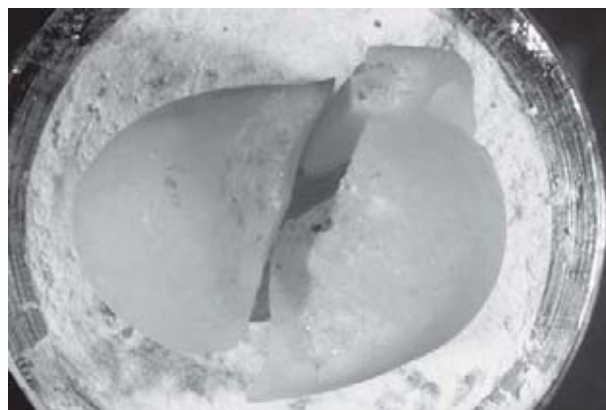
**Figure 3-** Fractured specimen after application of compressive load
